Manhole Inspection Summary

Manhole # S47CC_064MH

Insp Date: **2/7/08 9:00 AM**

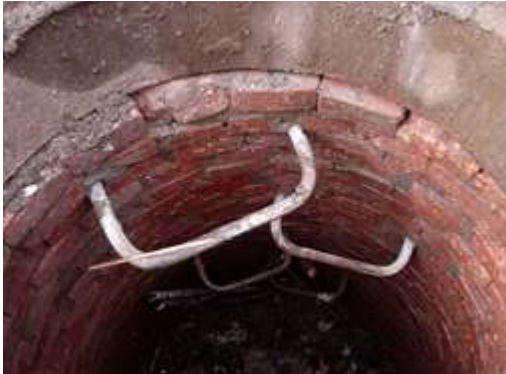
Defect 1

Condition: ☐ Sound ☐ Cracked ☐ Root Intrusion ☒ **Loose Brick** ☐ Deteriorated

Infiltration: ☐ None ☒ **Joint** ☐ Cracks ☒ **Mortar** ☐ Roots ☐ Wall

Loose Bricks

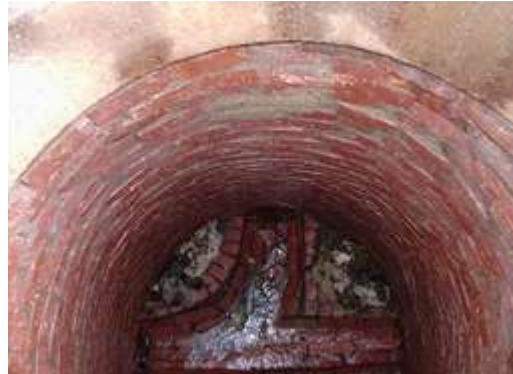
Defect 2

☒ **Leaks**

Frame Leaks

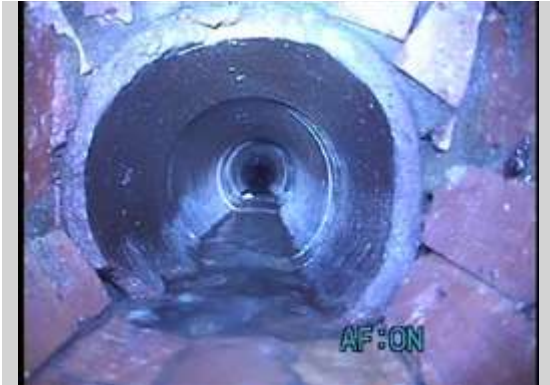
12 O'Clock Outflow

8 in. Circular Gravity Sewer
Pipe Out @ 12 O'Clock

Pipe Height: **8.4** (in.) Rod and Bar (Angled)
Pipe Material: **Clay** ☐ Pipe Lined
Invert Depth: **9.20** (ft.) Flow Characteristics: **Slow**
Deposits: ☒ None ☐ Mud ☐ Sludge ☐ Debris ☐ Grease
Silt Depth: (in.) Deposits Extent:
Infiltration: **None** Pipe Seal Cond: **Sound**

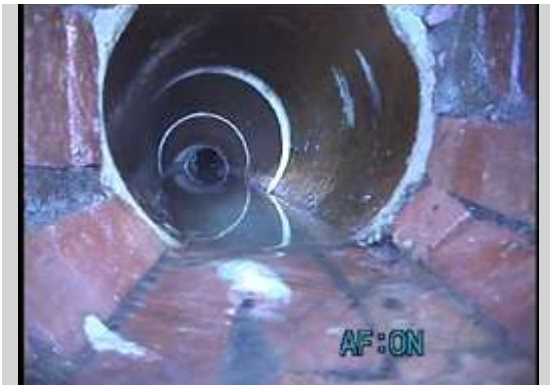
3 O'Clock Inflow

10 in. Circular Gravity Sewer
Pipe In @ 3 O'Clock

Pipe Height: **8.4** (in.) Rod and Bar (Angled)
Pipe Material: **Clay** ☐ Pipe Lined
Invert Depth: **9.10** (ft.) Flow Characteristics: **Slow**
Deposits: ☒ None ☐ Mud ☐ Sludge ☐ Debris ☐ Grease
Silt Depth: (in.) Deposits Extent:
Infiltration: **None** Pipe Seal Cond: **Sound**

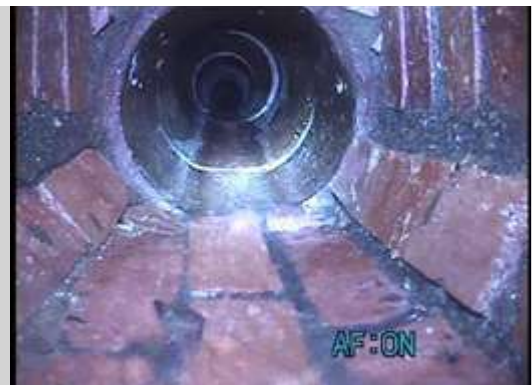
6 O'Clock Inflow

8 in. Circular Gravity Sewer

Pipe In @ 6 O'Clock

Pipe Height: **8.4** (in.) Rod and Bar (Angled)

Infiltration: **None** Pipe Seal Cond: **Sound**
